Examination and Reassembly

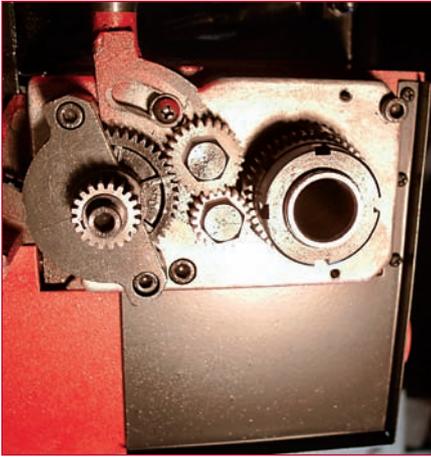
10 Tumbler lever down travel is impeded by contact with the casting.

The alloy belt cover was then refitted. Before adding the tumbler bracket, a small amount of metal was filed away from the foul point mentioned above. The tumbler was then fitted, ensuring that clearance existed between the nylon gear and washer mentioned earlier and shown in **photo 11**. Metal was also removed from the cast carrier, **photo 19**, which was then refitted along with the associated gears after lubricating the bearings.

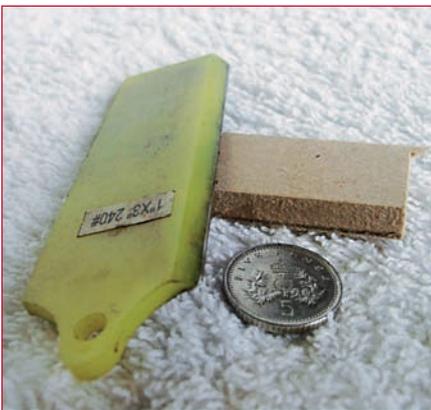
13 The diamond lap has been carved away at an angle to permit access to the root of the dovetails.

lap. The lap has been modified by trimming away the plastic backing at an angle to allow it to get fully into the corners of the dovetails, **photo 13**.

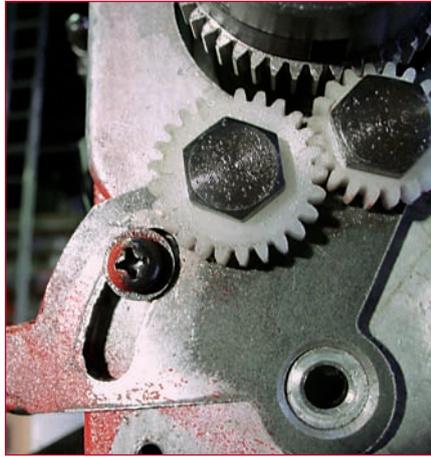
11 Showing clearance between larger white gear and washer.

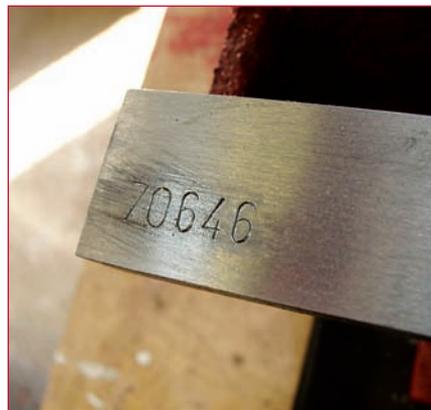
The serial number is stamped into the upper working surface after grinding and this causes metal to be raised around the edges of the numerals. Taking the raised material off with the lap left the number still easily legible, **photo 14** and improved the sliding action over this area. This area is unlikely to be used at the very end of the bed, but model engineers are notorious for stretching machine capacity so you never know. The lower working surfaces of the saddle were then coated with "Copaslip" (Arc use this) and the casting slid back on to the bed.

14 Raised metal around stamped numbers has been dressed off with lap.

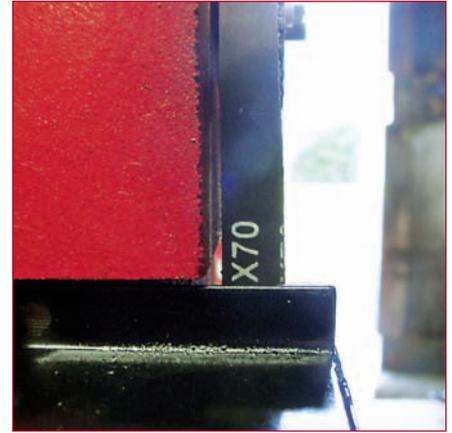
12 After adjusting the motor position, clearance has been gained between the belt and the headstock casting.

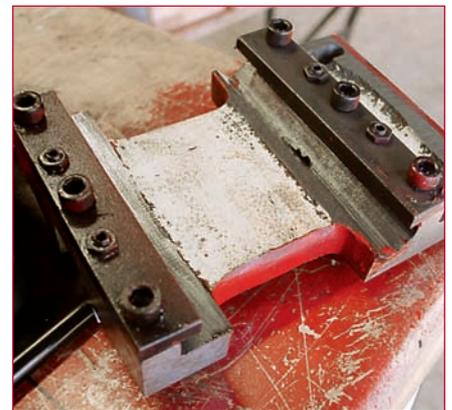
with locknuts are also fitted and these function to push the strips downwards and set a working clearance. The arrangement may be seen in **photo 15**. Thus the adjustment sequence is a repetitive process of lightly adjusting the opposed push - pull actions to achieve a good fit and feel. It should be noted that firm tightening of the pull up screws is not required and in fact, if overdone (according to web notes) may actually cause fracture of the strips.

15 Underside view of saddle shows "push - pull" adjustment screws.

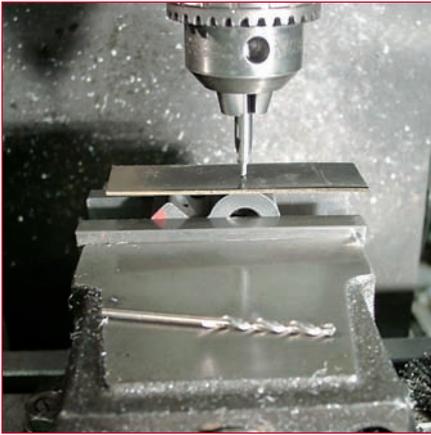
While it would be possible to do the drilling on the C3 using the milling attachment, as the lathe was in pieces, the simpler alternative was to use the VMC mill. **Photo 16** shows the RH bearing gripped in the vice canted up 45 degrees and a piece of thin sheet brass used under the point of the drill to get close to the centre of the curved surface. (When the brass was horizontal, the drill was close to the centre.) The bearing length is 20mm so the hole was drilled 10mm from one end.

16 The RH leadscrew bearing being set up for drilling an oil way.

Following the Arc example, a Minicraft drill with a small burr, was then employed to cut a diagonal oil way within the bearing. The 45degree cant mentioned would ensure that the oil hole would be conveniently accessible after assembly. A

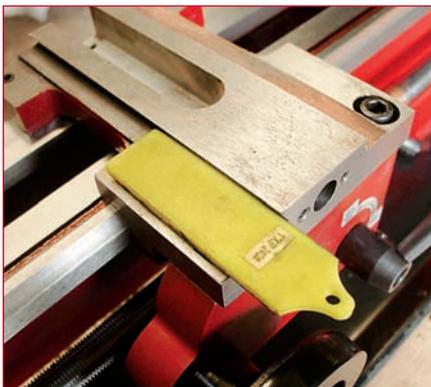
18 Milled surface of the cross slide dovetail is lightly rubbed with the lap.

The lap was again brought into play for the cross slide and top slide dovetail surfaces – just a gentle rub to clear any high spots, **photo 18**. The cross slide with its lead screw, bearing and handle were then added, again with a measure of Copaslip lubricant. The gibs on these

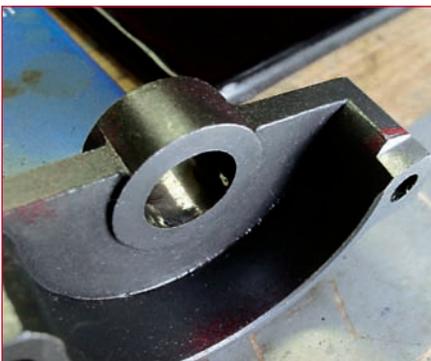
19 Showing the step filed to ensure correct movement of the tumbler assembly.

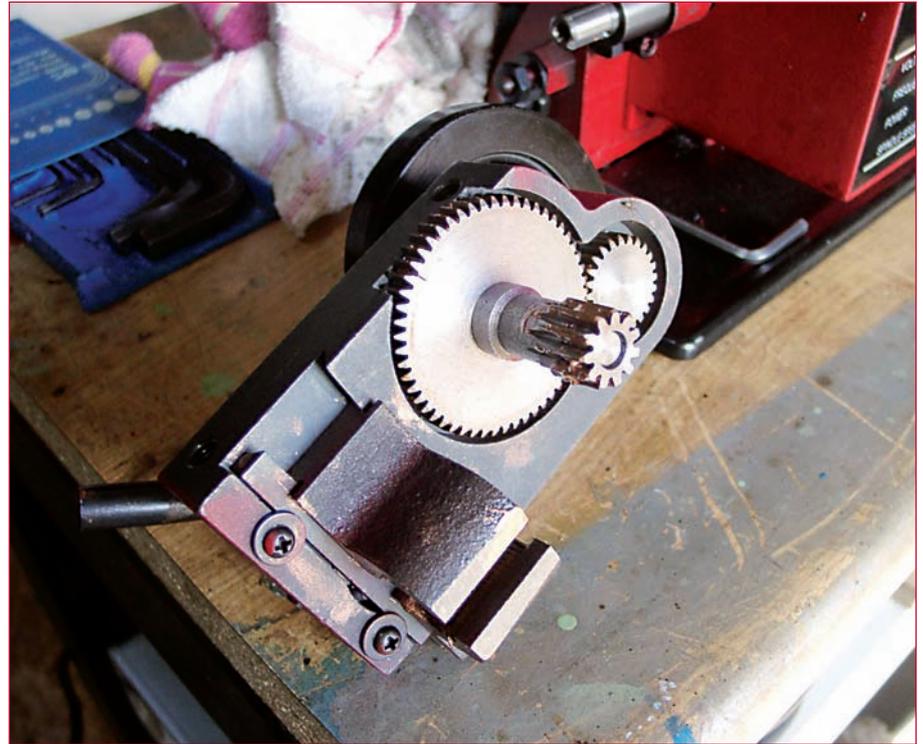
Attention was then given to the apron assembly. The half nuts were removed, and their respective dovetails given a touch with the lap. These, the shafts and the gears were reassembled with more Copaslip, **photo 17**. With the bearings and leadscrew also given a dose of Copaslip, the LH bearing with leadscrew could be jury rigged. The apron (with clasp nuts open) was then carefully threaded over the leadscrew and loosely attached to the saddle. After fitting the RH leadscrew bearing, the screws holding the LH were tightened whilst pressing the bearing towards the right. Similarly, the RH bearing was nipped up whilst applying pressure towards the left. (The reason is that the leadscrew end float is set by the relative positions of the two bearings and

17 Inside view of the apron showing the half nuts and gears.

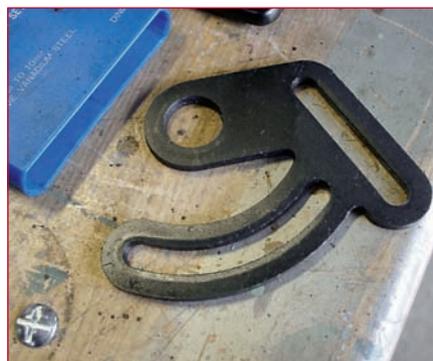
20 The tumbler bracket is a pressing with sharp edges on one face.

Examination of the changewheel bracket showed this to be a pressing, **photo 20** with sharp edges on one side. These were dressed off with a file before the bracket with wheels was added, after locating a single washer behind, which would bring the gears into better alignment, **photos 21A & 21B**.

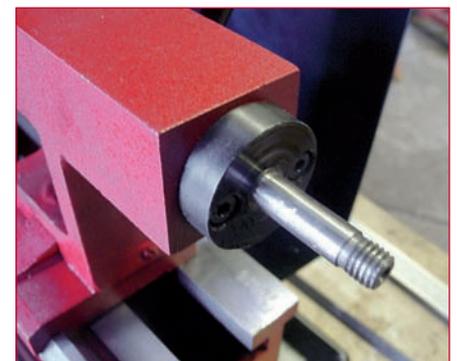
22 Shows the burr raised by the tailstock hand wheel grub screw

The tailstock upper and lower sections were not separated at this stage although the barrel and screw were removed for lubrication. While this was in pieces, the opportunity was taken to lightly chamfer the end of the barrel, removing a sharpish edge. It was also noted that the hand wheel is retained by a cup point grub screw which had marked the shaft, **photo 22**. The marking was dressed away with a fine file, and a small brass disc inserted below the screw. In contrast, the carriage hand wheel is held by a cone point screw and in this instance, the point locates in a

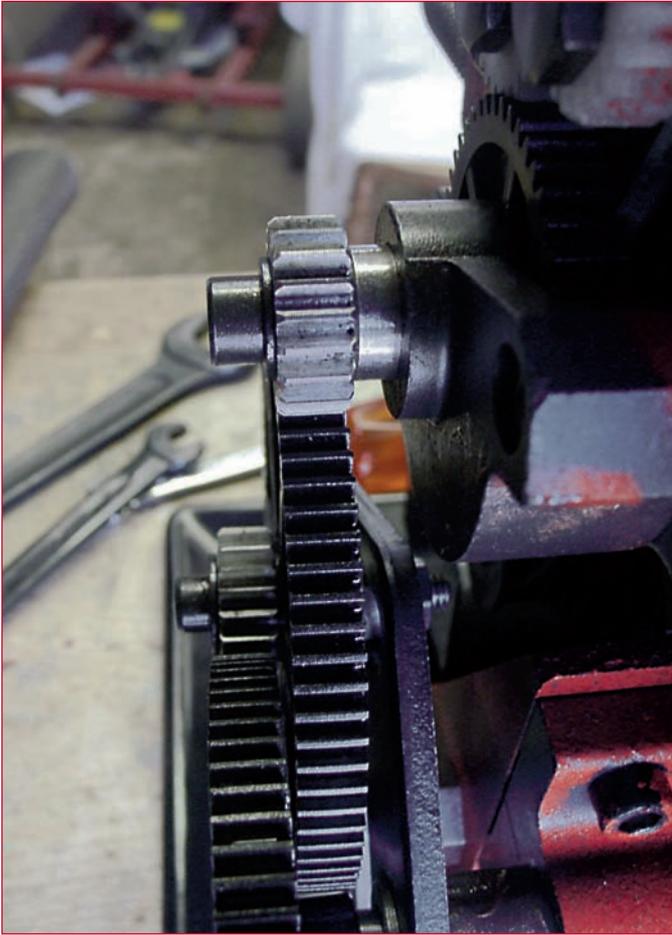
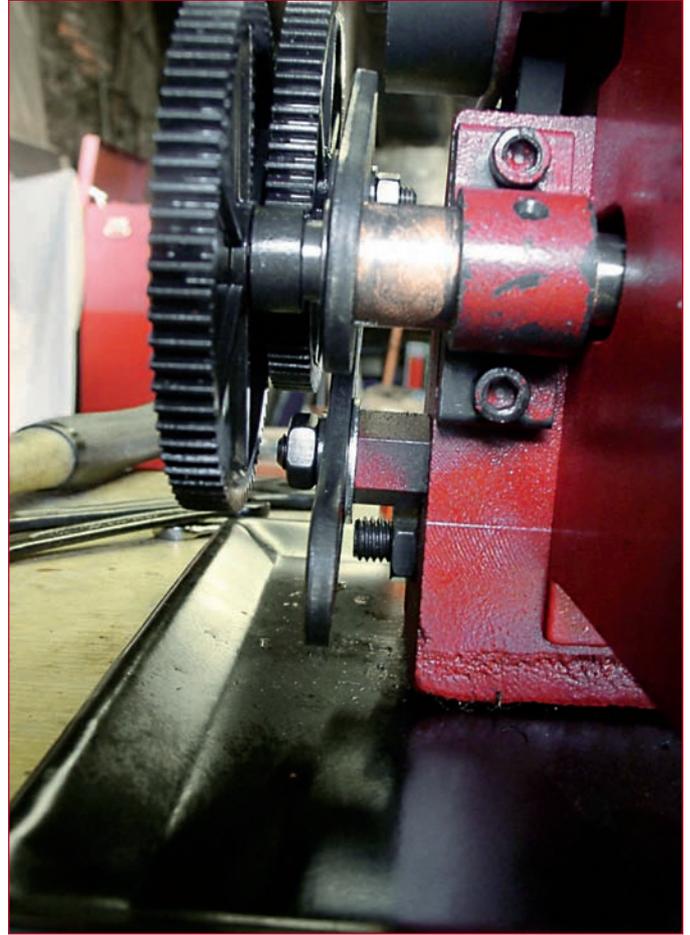
21A The gear alignment has been improved --

21B --- by the addition of a washer.

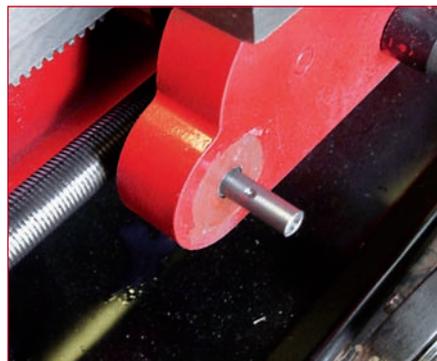
23 The grub screw on the carriage hand wheel has a drilled recess.

drilled recess, **photo 23**.

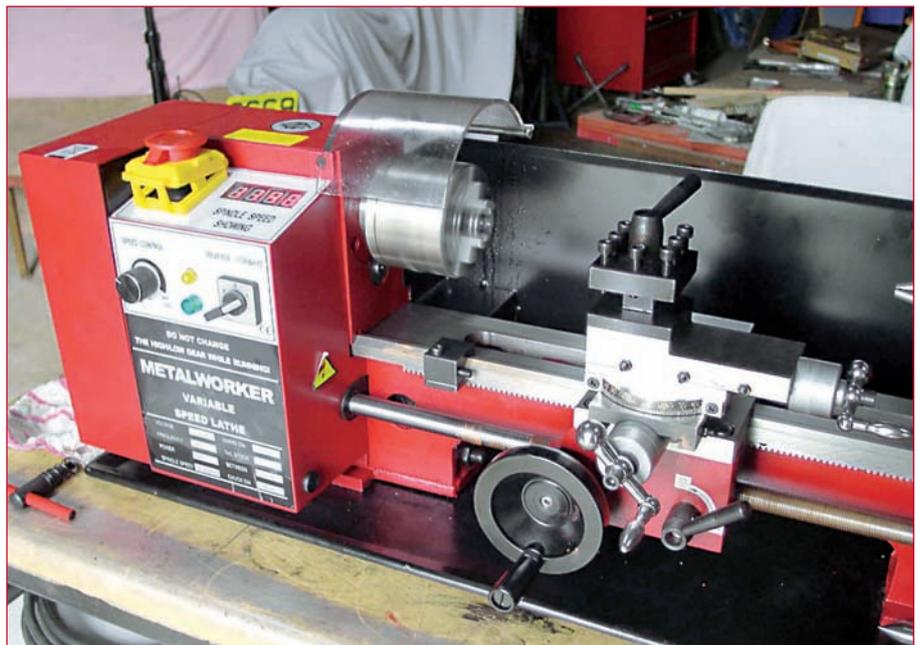
Fitting the change wheel cover, splash back and chuck guard completed the exercise after which the machine was fired up, **photo 24** running the saddle under power feed backwards and forwards several times to check operation. Operating the various slides manually was now noticeably smoother compared to the earlier, as received "Factory assembled" condition.

24 Assembled and under power.
