The C3 Mini Lathe ①

This is the first of a series of articles based on the C3 Mini Lathe, commencing with description, strip down and rebuild. Later articles will look at the range of accessories available and their application and then move on to consider modifications and home built accessories.

Dave Fenner takes a look at smaller scale working

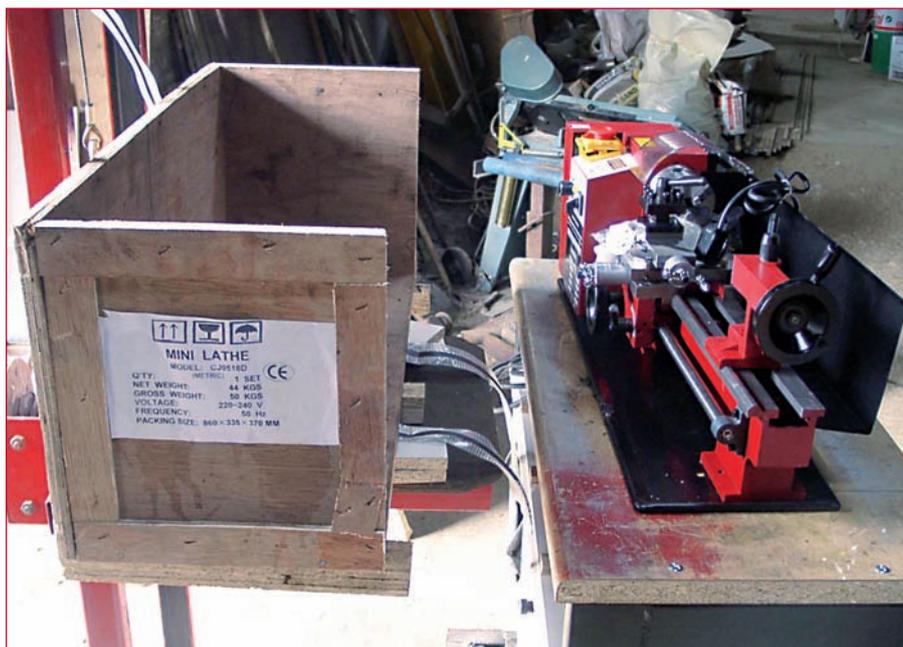
2 The lathe has been slid across on to the bench to be bolted down.

chosen sequence was to remove the top and one side, **photo 1** then remove the bolts. The barrow platform was then raised so that it became an easy matter to slide the machine across on to the bench, **photo 2** where it was bolted down through the worktop using lengths of M8 screwed rod.

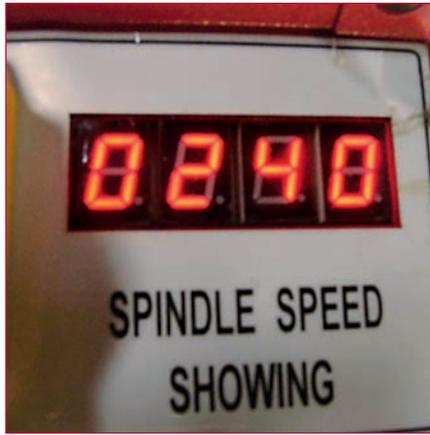
4 The tachometer shows the spindle speed.

There is also a built in tachometer, **photo 4** and it was found that in low gear, 40rpm was achievable at the lower end of the range. However, as this low speed is obtained by motor control (rather than reduction gears) the transmitted torque will not be massive.

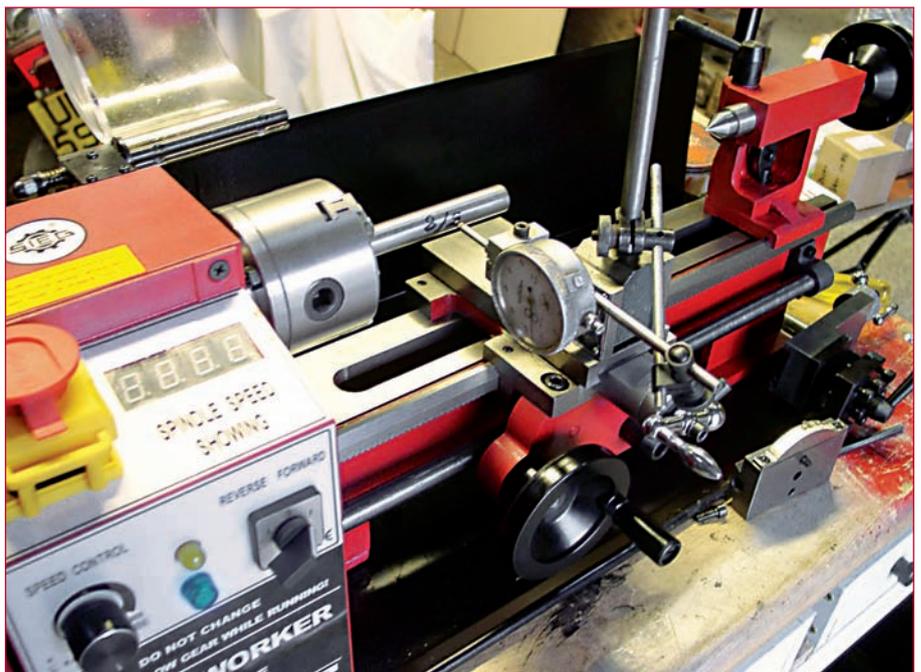
5 Checking headstock alignment and chuck run out.

A quick check on headstock alignment was made using a rough and ready method employing a silver steel bar gripped in the three jaw chuck and a clock gauge mounted on the saddle, **photo 5**. This indicated a small error in the horizontal plane (less than a thou over four inches) and nothing measurable in the vertical. This would imply that work held in the chuck and turned nominally parallel will always exhibit a slight taper, of some 0.0002in per in., however this inaccuracy is unlikely to cause difficulties since 1, it is likely that parts made on the machine will not be long, and 2, where this level of precision is needed, finishing would probably be by filing/lapping.

The same set up was also used to look at the accuracy of the chuck and here the run out was one and a half thous at one inch from the chuck jaws, so comfortably less than a thou eccentricity.

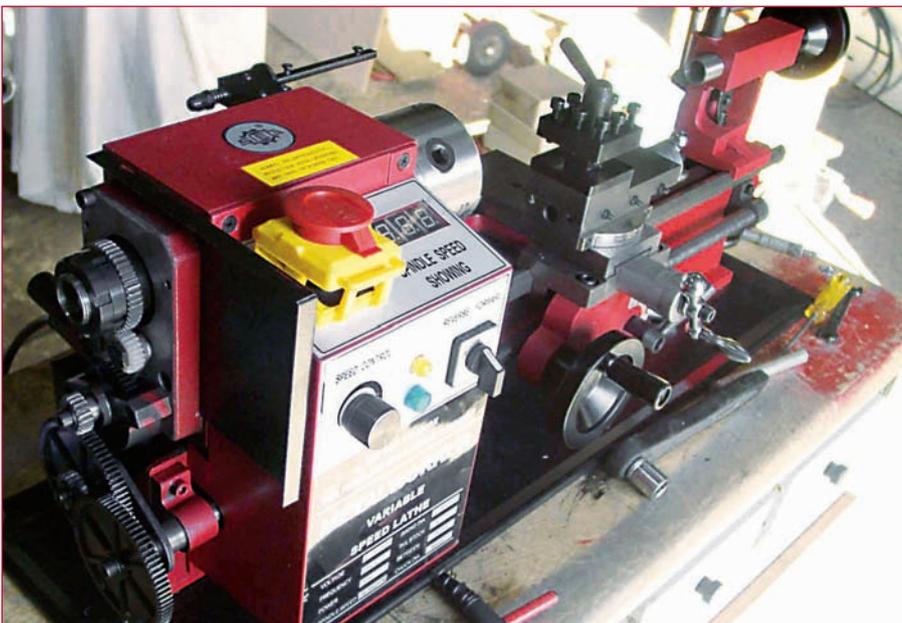
8 Chuck guard, splash back and gear cover have been removed.

The first components removed are the chuck guard, (two Pozi screws), the splash back (more screws) and the change gear cover (two long Allen screws), **photo 8**. With the change gears exposed, it is possible to observe the general alignment of the meshing. As can be seen from **photo 9**, the gear alignment is out by a couple of mm or so, resulting in incomplete contact across the teeth which could lead to premature wear or even breakage. Two solutions may be considered – a) lightly bend the support plate with a lever or b) add a washer at reassembly to bring the assembly into line. I chose the latter course.

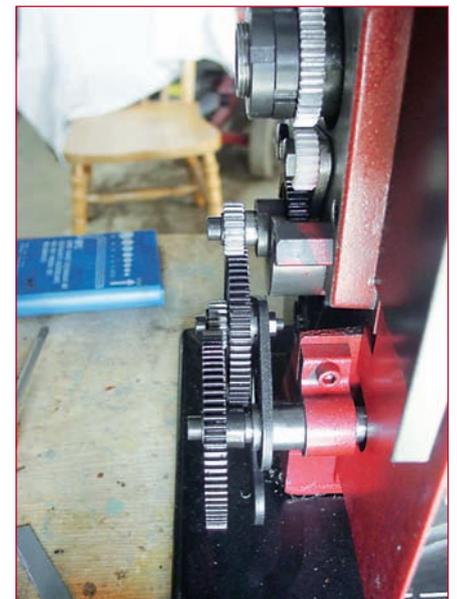
9 Showing the misalignment of the change wheels.
